Service Bulletin No 105/93 SWIFT

BULLETIN No BE 105/93 SWIFT

Strengthening of the structure of the pedal arms in the rudder control system

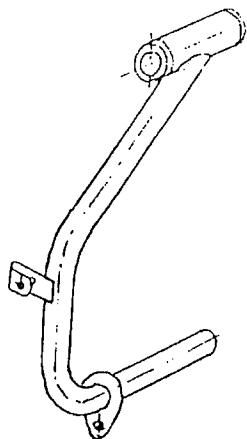
Existing arm

On the Fifth world Glider Aerobatic Championships in Venlo (The Netherlands) damage to the pedal arm in the rudder control system occurred twice during the same aerobatic manoeuvre (recovery from a quick vertical roll).
