Mandatory Bulletin No BO-11/98 MDM 1-FOX**Concerns:**

Additional inspection of aileron-drive fitting.

Zakład Remontów i Produkcji Sprzętu Lotniczego
Edward Margański _ Bielsko-Biala

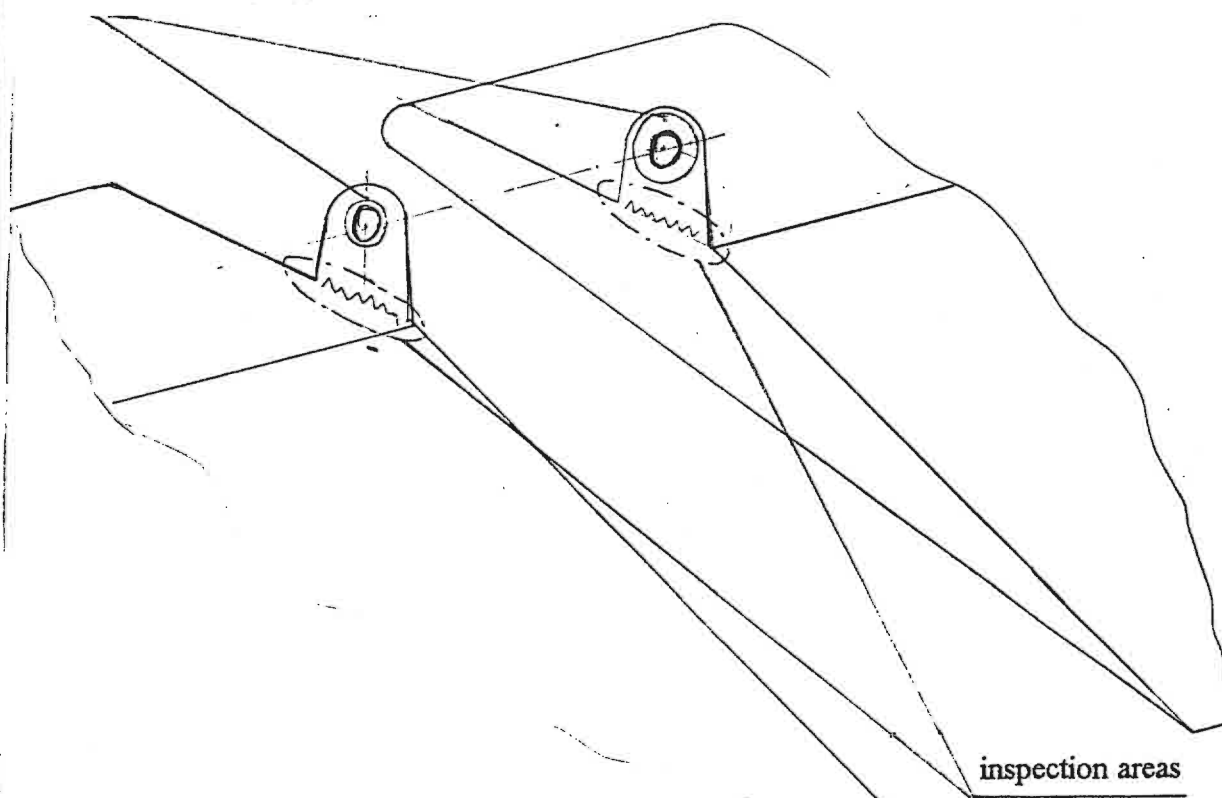
item 3, Fig. 6 of „Technical Service Manual” (Issue III and Issue II)

A fracture to the aileron-drive fitting of the left-hand aileron occurred in a factory No 215 glider. The fracture has most probably evolved from former exceedence of the allowed tail-slide time, resulting in violent and uncontrolled aileron load being developed - see limitations on page 4.9 of „Flight Manual” (Issue III), or page 4.10 of „Flight Manual” (Issue II).

- a) after previous cleaning off the lacquer, check aileron-drive fitting (metal part) against fractures in the areas indicated on the drawing, use magnifying-glass of at least x5,

- b) after inspection secure cleaned elements against corrosion with a transparent epoxy lacquer (next inspection will then not require cleaning the fittings),
- c) record executing the inspection in glider's log book,
- d) after eventual identification of fractures, notify immediately the glider's producer sending an appropriate photographic and descriptive documentation,
- e) in this case the glider is grounded until the identified defects are removed,

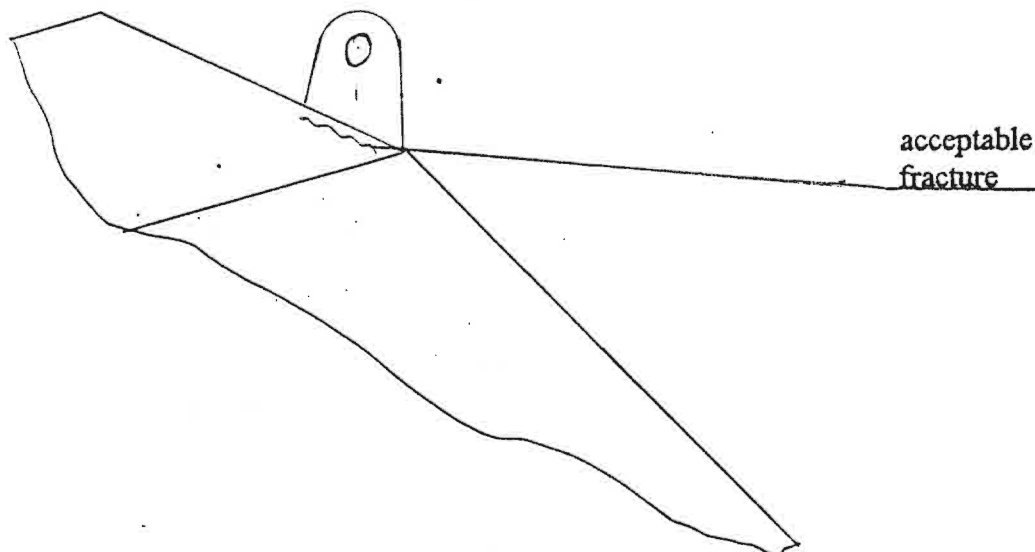
- f) fractures to lacquer and these to underlying thickened resin at fitting - aileron connection are acceptable,
