## SERVICE BULLETIN No BO-21/2015 MDM-1 FOX

DESIGNATION-TYPE/MODEL: MDM-1 FOX

CONCERNS: Inspection of front node in tailplane mount, and  
repair with modification – as necessary

Bielsko-Biała, 14.09.2015

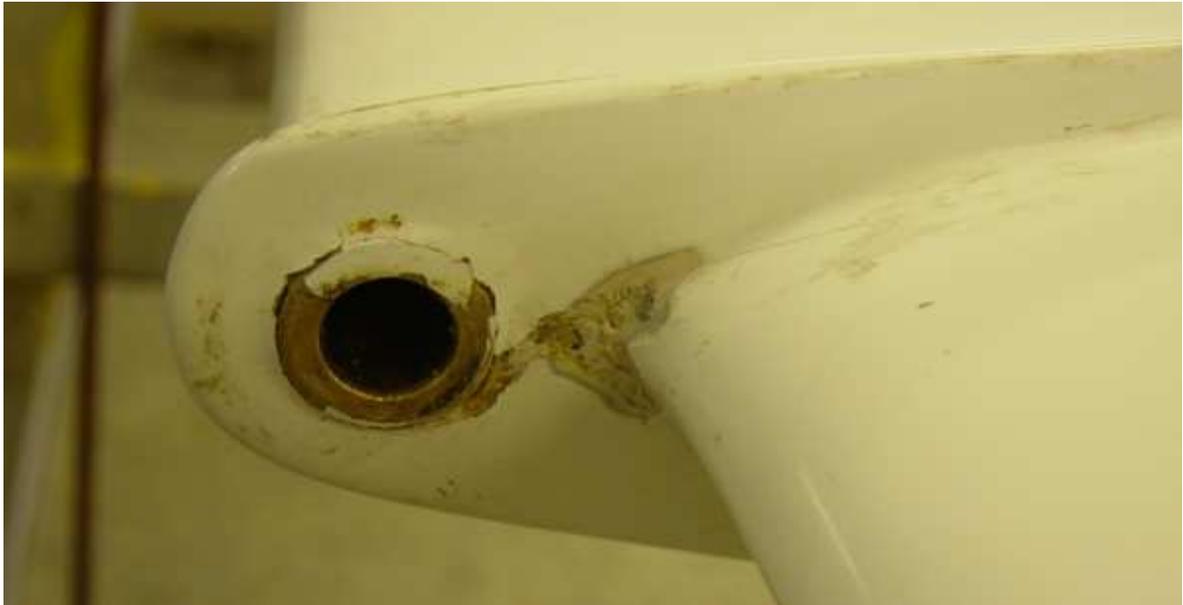
In the glider inspections carried out for every reported occurrence, identified were cracks around the front fitting metal sleeve in the composite rib installed on stabilizer, and in the bonded joint between rib and stabilizer, of extent/ size varying between individual cases.

1. In case of encountering the tailplane excessive play (lateral bank) and/or unusual in-flight vibrations, or at the nearest annual/ 100h inspection (whichever occurs first), inspect the front node of stabilizer mount against possible cracks on the outboard, side surface of composite rib around metal sleeve and in the area of rib to stabilizer bonding.

*Possible form of damage to tailplane mounting node*

2. Investigate the extent of every crack detected: verify if this is limited to lacquer & filler coat, or penetrating into composite. To do so, carefully remove the lacquer in the area of crack and check the condition of uncovered composite against presence of cracked fibres and/ or white spots being evidence of damage in composite.
3. Detected damage to composite structure must be repaired before next flight, by implementation of design change described in the WORKING INSTRUCTION, see item 5 ENCLOSURES.
