BULLETIN No BE 03/96 MDM1-FOX

Enlarging the gap between the edges along the wing section contour , in the wing - fuselage connection .

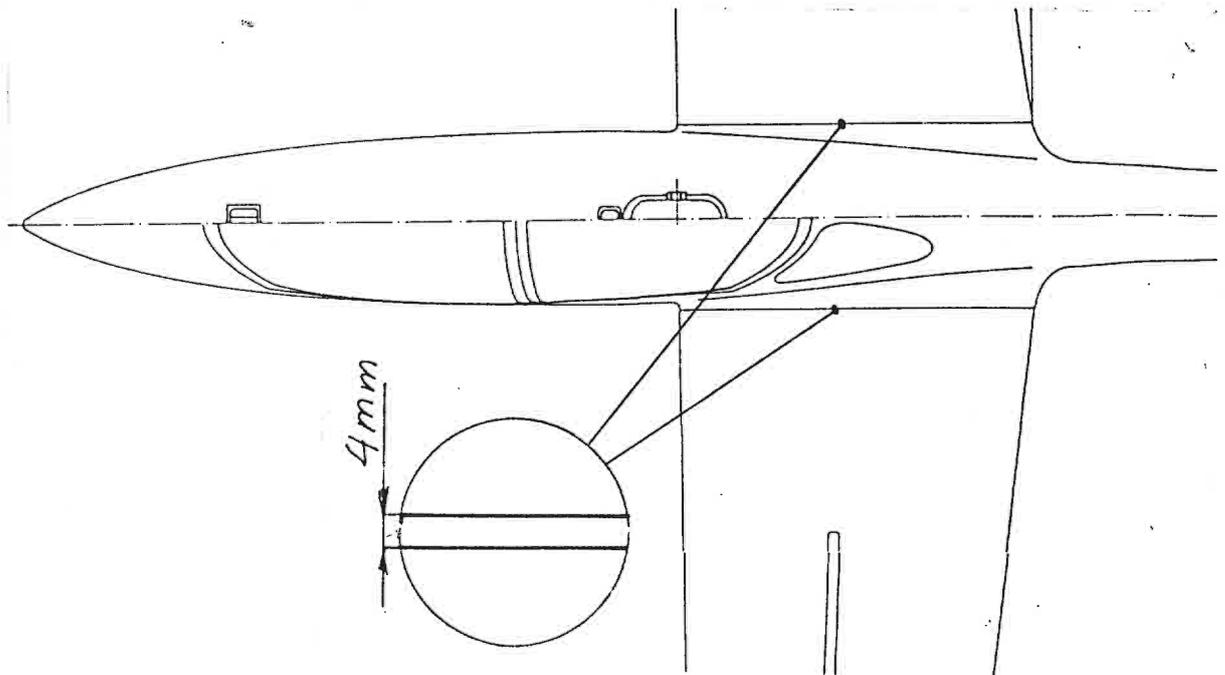
Basing on observations made both on gliders under operation and on the plane subjected to fatigue testing it has been found that the gap between the edges, in wing-fuselage connection, at maximum loads may be insufficient.

In some cases, the wing shell may touch the edge of fuselage, thus introducing additional stress.

On the rigged glider grind the edge of wing shell (on both wings) over the whole wing section contour, till obtaining in wing - fuselage connection the constant gap size of 4 [mm].

On the wing spar portion, cut out the shell with blade, with special attention paid to avoid incisions to spar fabric.

Protect the grinded edges by covering them with lacquer or resin composition.
